SIMULATION OF THE 1755 TSUNAMI FLOODING AREA IN THE ALGARVE (SOUTHERN PORTUGAL) : THE CASE-STUDY OF PORTIMÃO

Fantina Tedim, João Gonçalves
Faculdade de Letras, Universidade do Porto
fpedrosa@letras.up.pt

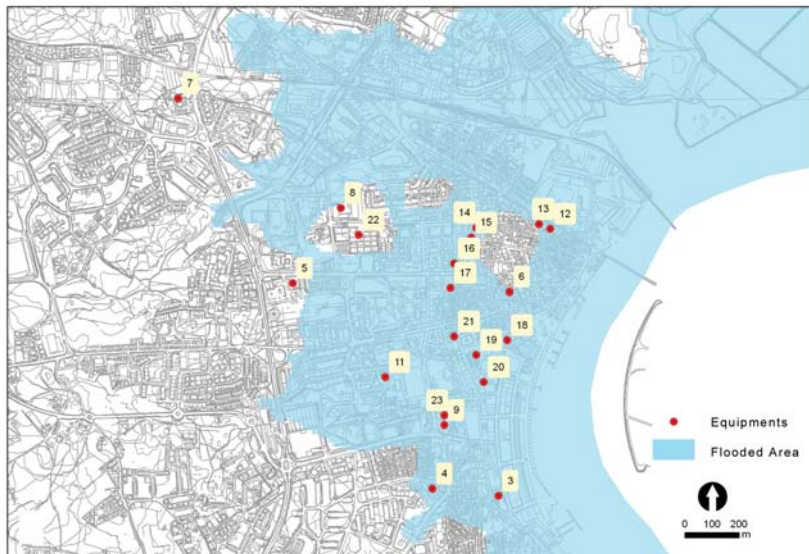
Figure 6- Institutions: 1 - Portimão Private Hospital, 2 - Alvor Health Centre, 3 - Public Health Centre (SSP), 4 - Public Health Centre, 5 - Portimão Misericórdia Hospital, 6 - Red Cross, 7 - National Republican Guard (GNR), 8 - Portimão Volunteer Fire-fighter Association, 9 - Police Force (PSP), 10 - Water and Residues Company, 11 - Prison, 12 - Revenue Payments Office, 13 - Revenue Office, 14 - Civil Registration Office, 15 - Employment Office, 16 - Portimão Local Government, 17 - Cape Verde Consulate, 18 - Sweden/Iceland Consulate, 19 - Criminal Police, 20 - Portugal Telecom, 21 - City Hall, 22 - Graveyard, 23 - Municipal Police, 24 - Airodrome.

In a disaster situation, the management of rescue means and security forces is essential. From our analysis, it is possible to conclude that in the established scenario the structures of civil protection agents would not be severely damaged (Figure 6). Only the police headquarter is located in a potential flooded area but fire-fighter brigades and other security forces will not be affected.

The aerodrome, important equipment allowing easy access of rescue means or the evacuation of inhabitants, is located in freguesia de Alvor in an area easily affected, since it is located at a height of 5 metres and on the bank of the Alvor River, up which the tsunami would advance.

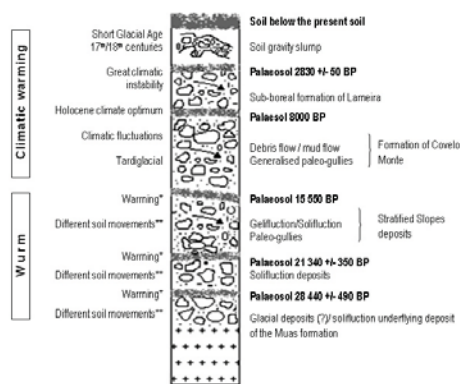
Fig. 3 – Stratigraphic column of the superficial formations in the area of the Serra do Marão.

*Warming and higher degree of moisture
**Debris flow, gelifluction and solifluction pockets of bits of rock broken by gelifraction

The oldest deposit found in the Marão is prior to 28000 BP; it was possible to find a palaeosol that fossilises it dating back to 28440 +/- 490 BP. It may correspond to the so called Würm II (PERÇA, A., 1993). It is a deposit with heterometric characteristics, probably the result of the deposition of material transported by debris flow, although the possibility of its having resulted from glacial action is not to be put aside (Fig. 3).
