Diebold TSx Evaluation

SECURITY ALERT: May 22, 2006 **Supplemental report, additional observations**

A Black Box Voting Project
Prepared by: Harri Hursti

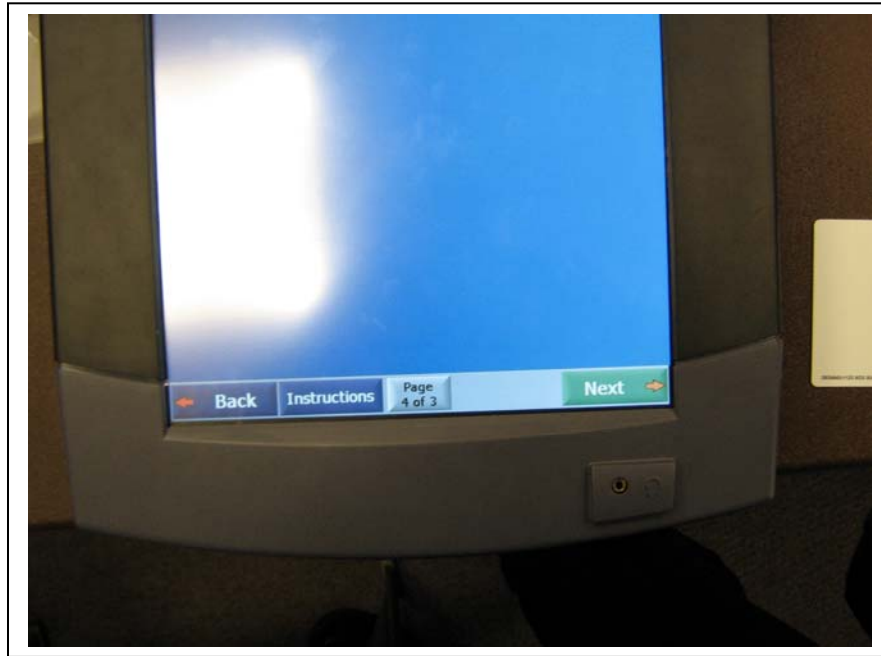
Fig. 1 – Macro skips to "Page 4 of 3" of 3 page ballot and stops without error message while macro feature is still active

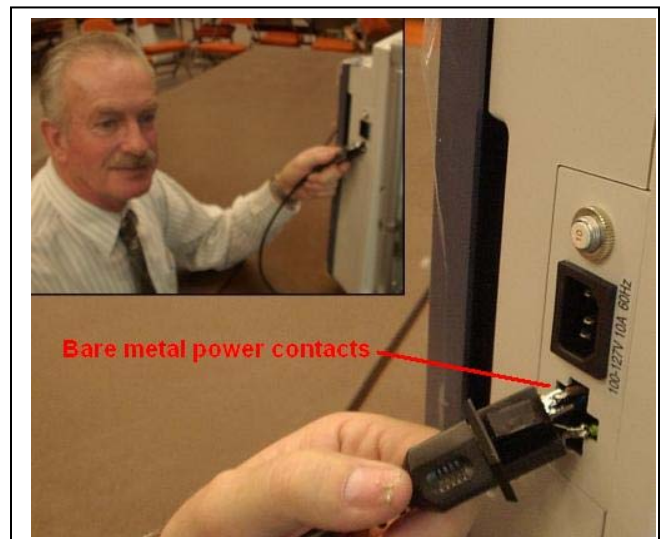
The electrical sockets on the TSx are not properly fitted to the case. Every unit examined revealed problems with sockets popping out or falling out, sometimes by simply moving the machine or through light contact with the cord.

Because many polling places lack sufficient wall outlets to plug in all the machines, these machines are typically daisy-chained together (one machine plugged to the next) with a single machine plugged in to the wall. The improperly designed socket design presents potentially an electrical hazard to poll workers and voters.

Fig. 4 – Exposed 110 volt wiring and socket falling out

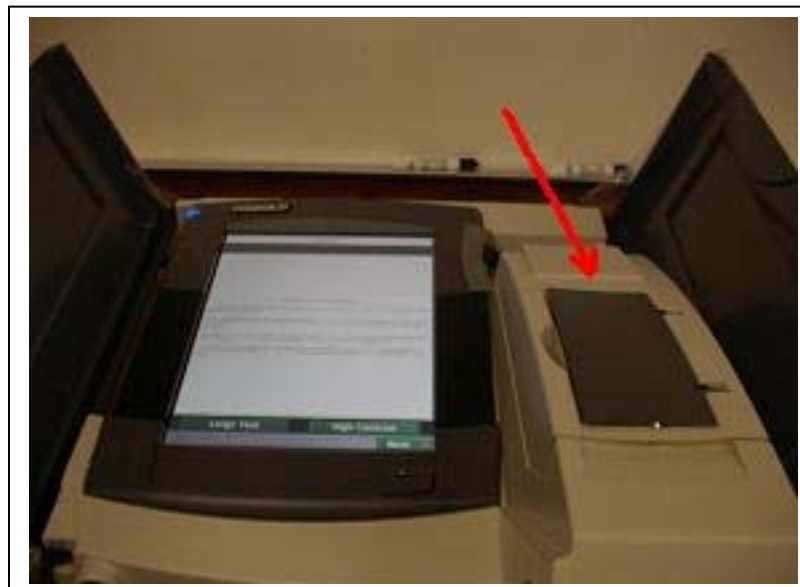
In addition, a design decision to place a brown door over the paper which the voter is supposed to verify leads to questions about the usefulness of the VVPAT. Unless the door is lifted up it obstructs view of the paper representation of the voter's vote. If the system is to be used to verify a paper trail, it should have instructions printed prominently on the casing instructing voters to lift the brown door to see the paper trail.

Fig. 6 – Brown door blocking view of voter verifiable paper trail

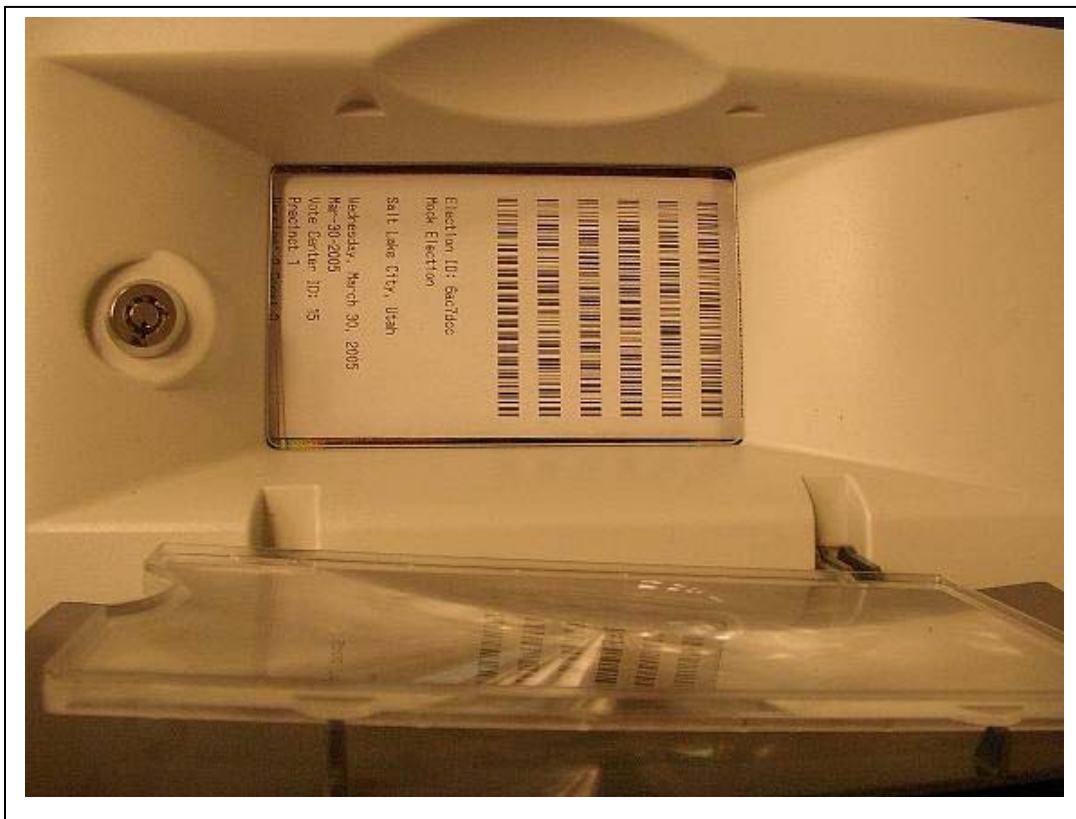
The voter can lift the lens, but the print is very small and the bottom of the paper record of the vote does not display fully.

Fig. 8 – Print is small; lower part of paper trail tends not to scroll up into full view.
